SPACE SHUTTLE ORBITER AUXILIARY POWER UNIT  
DEVELOPMENT CHALLENGESRenee Lance and Dwayne Weary  
NASA Lyndon B. Johnson Space Center  
Houston, Texas 77058ABSTRACT

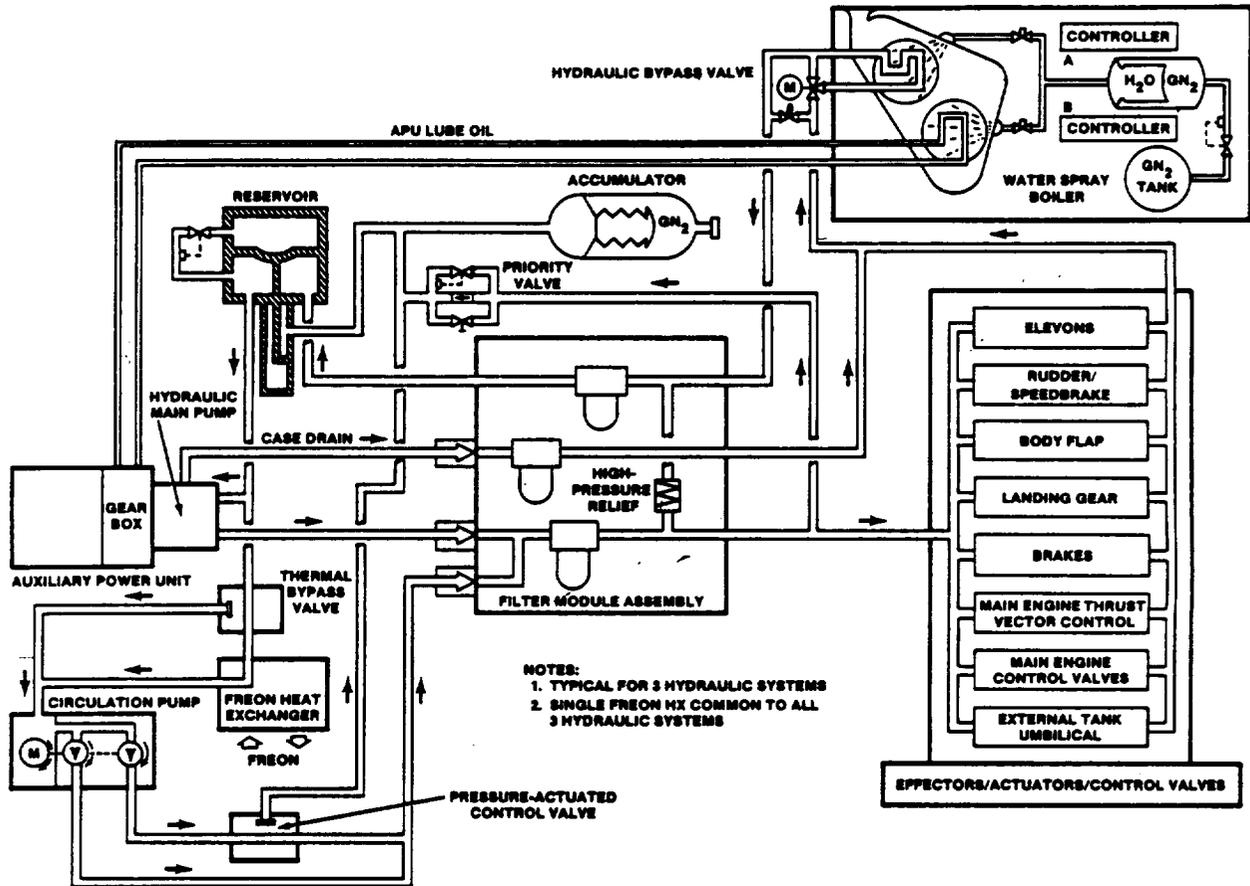
FIGURE 1.- ORBITER HYDRAULIC SYSTEM SCHEMATIC.

The Orbiter vehicle uses three complete APU subsystems and three hydraulic systems. The APU's, including their fuel systems, are isolated from each other. Pressure-actuated cross-links are provided between the hydraulic systems so that in case of a failure in a single APU or hydraulic system, the remaining two systems can accommodate the total hydraulic load.

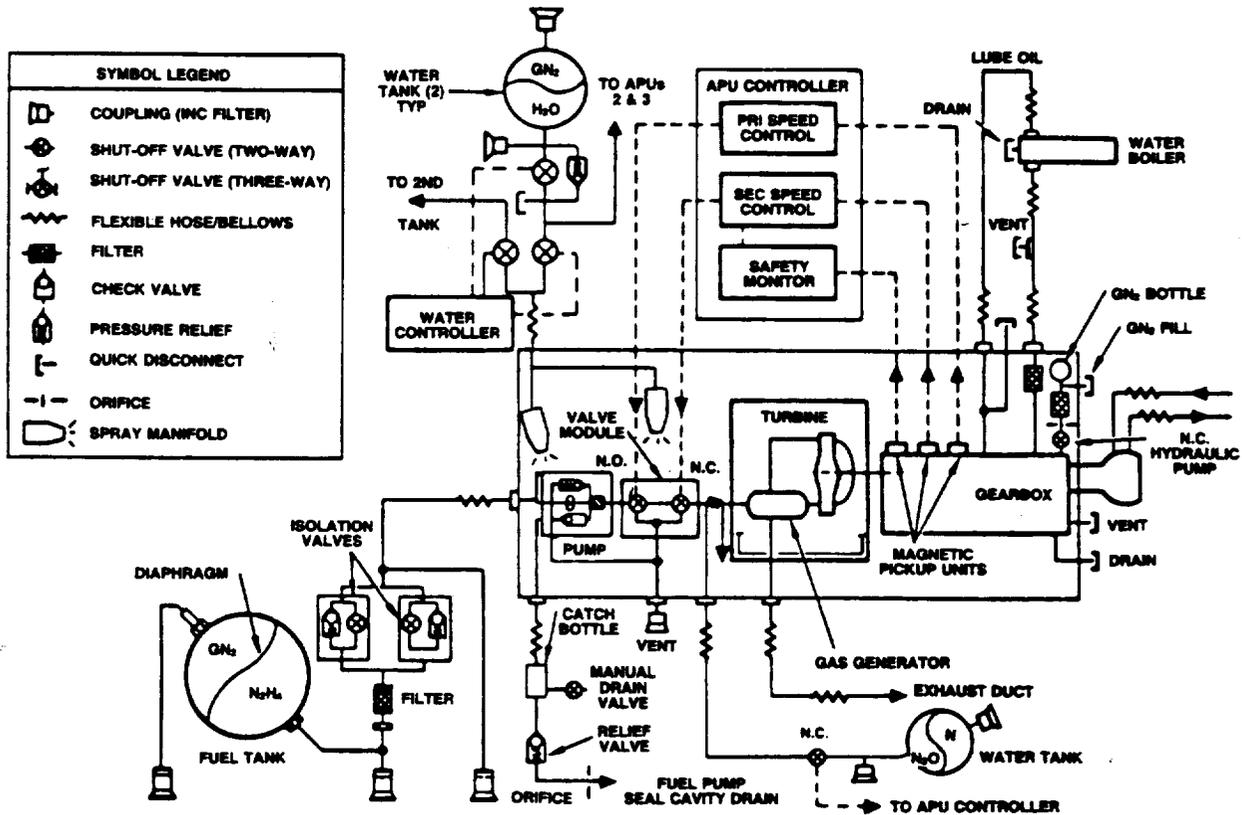
FIGURE 2.- AUXILIARY POWER UNIT SUBSYSTEM SCHEMATIC.

A functional schematic of the APU subsystem is presented in figure 2. Figure 3 shows the APU configuration. The Orbiter installation is shown in figure 4, in which the locations of the fuel feed system, the fuel tankage, the water cooling system, and the water tankage are indicated.

Monopropellant-grade hydrazine fuel is supplied to the inlet of the fuel pump at pressures ranging from 80 psia (5.5 bars) to 370 psia (24.5 bars). The fuel pump increases the pressure to approximately 1500 psia (103 bars). The high-pressure fuel is directed through the gas generator valve module (GGVM) to the gas generator (GG). The GG catalytically decomposes the fuel into gas at a temperature of 1700° F (927° C) and at a nominal pressure of 1260 psia (86.5 bars); the gas is then directed through a two-stage, supersonic reentry turbine. After work is extracted by the turbine, the gas is used to cool the gas generator by flowing over it before exiting the APU.

Once turbine operating speed is achieved, it is controlled within +8 percent by the GGVM, the electronic controller, and speed sensors. Three redundant speed sensors mounted at the turbine shaft provide the electronic controller with pulsed speed signals. The primary nominal turbine operating speed is 75 000 rpm. If the primary speed control mode fails, a secondary speed control mode of 81 000 rpm is activated automatically. This secondary mode may also be selected manually in the event the APU is required to have greater load-carrying capacity. Should the secondary speed control mode fail, a backup (part of the primary circuit) control mode of 83 000 rpm is activated automatically. If both primary and secondary control modes are inoperative, automatic shutdown occurs at 93 000 rpm.

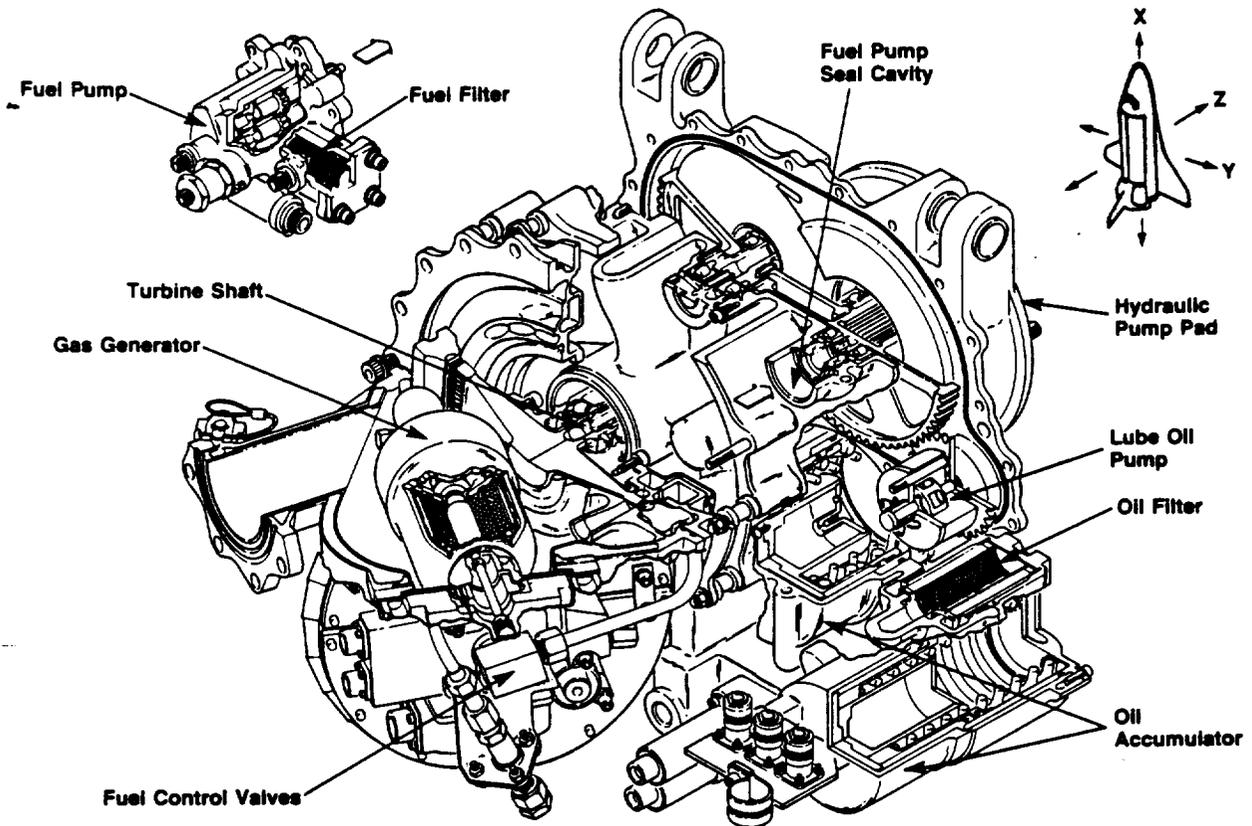
FIGURE 3.- AUXILIARY POWER UNIT ASSEMBLY.

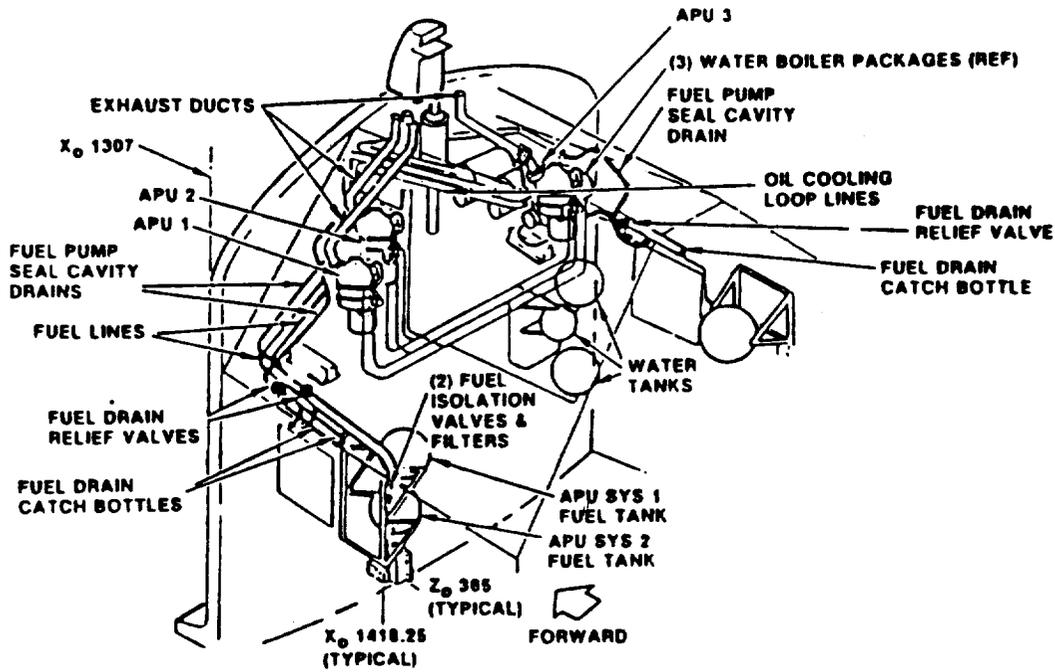
FIGURE 4.- AUXILIARY POWER UNIT SUBSYSTEM INSTALLATION DESCRIPTION.

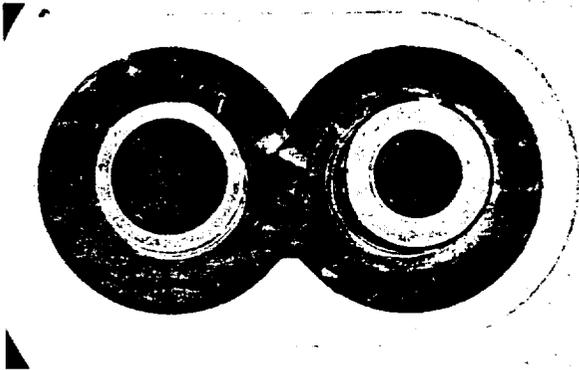
FIGURE 5.- APU FUEL PUMP GEARS, 17 TOOTH/16 PITCH.

Because of the very poor lubricity properties of hydrazine, galling of the fuel pump gears was an early problem that significantly limited pump life. The approach taken to resolve this problem was to reduce the pitch velocity, to design the gear teeth to minimize sliding contact between the gears, and to use a gear material less sensitive to galling. This change was accomplished by using a very hard material and many small teeth rather than a few large ones. The resultant design was a 16-pitch, 17-tooth gear made from M2 tool steel. This design is in use today and effectively provides unlimited fuel pump life (fig. 5).

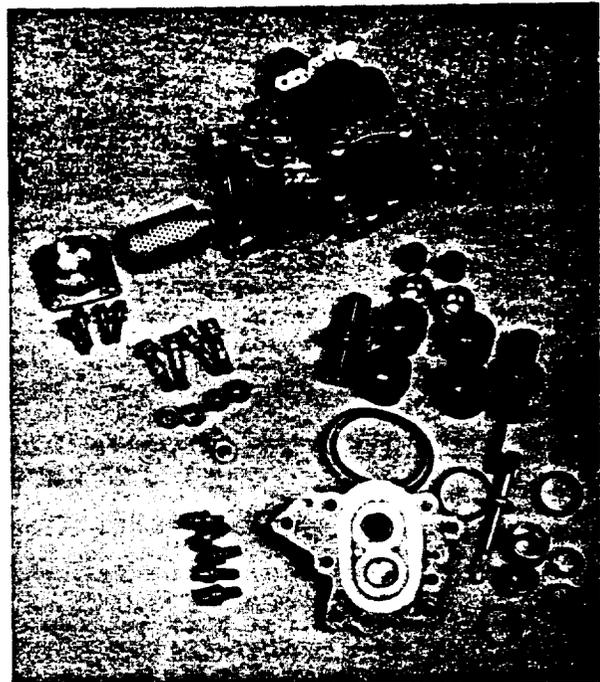
FIGURE 6.- APU FUEL PUMP.

During development testing, fuel pump drive-shaft seal leakage problems resulted in several design iterations of the bellows in the seal. These changes were not successful, and after a bellows failure during an Approach and Landing Test (ALT) flight, the bellows-type shaft seal was replaced with a seal that uses an O-ring in place of the bellows to seal between the carbon-face seal holder and the seal case. No further problems with massive fuel leakage due to seal failures have been experienced. A disassembled fuel pump is shown in figure 6.

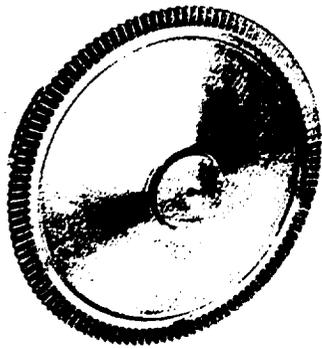
FIGURE 7.- TURBINE WHEEL.

The APU turbine wheel is a 5-1/4-inch-diameter, impulse-type turbine using a blade tip shroud (fig. 7). Early problems with the wheel included blade root cracks (fig. 8), shroud cracks, inadequate welds between the blade tips and the shroud (fig. 9), and blade trailing-edge cracks at the blade tips. The trailing-edge cracks propagated to the point at which pieces of the blades would break off. The combination of blade root cracks and shroud cracks led to at least one instance of loss of a blade and a portion of the shroud during APU operation (fig. 10). The trailing-edge cracking was found to be caused by aerodynamically induced fatigue acting on the very thin (0.005 inch) trailing edge near the tip of the blade. Analysis results indicated that this part of the blade could be removed with a small 45° chamfer at the blade tip without significant effect on performance. Testing later verified this as an acceptable solution for the problem.

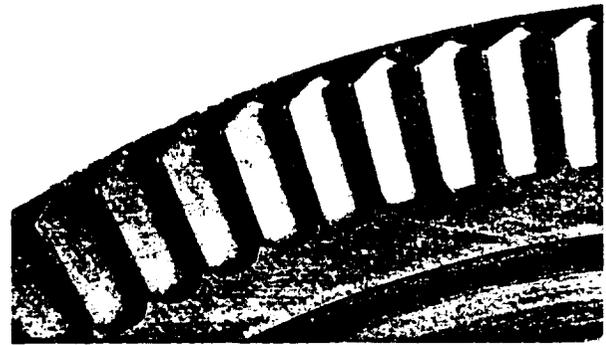
FIGURE 8.- AIRFOIL ROOT CRACKS AFTER 28 HOURS IN APU 102.

The blade root cracking was resolved by carefully controlling the blade root corner radiuses. Stress caused by sharp radiuses was found to cause the cracking. Careful design and dimensional control of the electrochemical-machining (ECM) tooling successfully resolved this problem. The shroud cracking situation was found to be related to both material selection and the welding process.

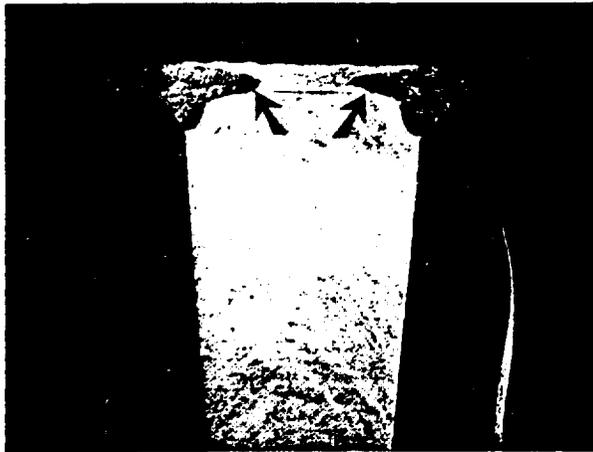
FIGURE 9.- METALLOGRAPHIC SAMPLE OF EB-WELDED JOINT RANDOMLY SELECTED. ARROWS DENOTE UNWELDED AREA IN CENTER OF JOINT (14X).

Increased strength and weldability characteristics were achieved by changing the shroud material from Hasteloy X to Inconel 625. Then, a very precisely controlled electron-beam (EB) weld procedure was developed to ensure full penetration weld across the chord of the blades without overheating the shroud. These actions eliminated the shroud crack problem.

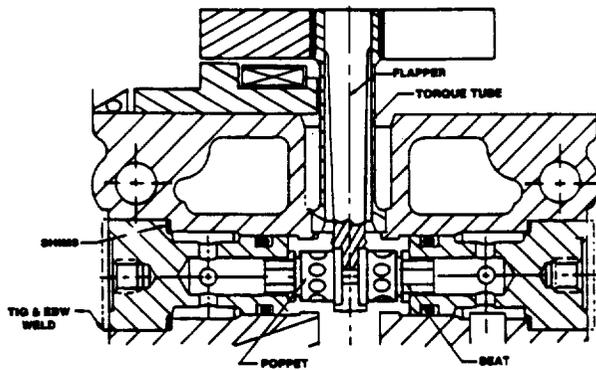
FIGURE 11.- CURRENT VALVE CONFIGURATION.

Development of a reliable valve (fig. 11) to control the fuel flow into the APU gas generator proved to be one of the most challenging tasks of the APU program. The valve is required to "pulse" fuel into the GG at frequencies of 1 to 3 hertz. Leakage requirements were stringent for both safety and efficiency reasons. In addition, the valve is exposed to significant pressure fluctuations (80 to 1500 psia per cycle) and must provide high response, yet have high reverse-cracking capability to seal against the GG pressure at valve closing.

The primary problems with the valve centered around leakage and limited life due to wear and failure (breakage) of the tungsten carbide valve seat. Considerable effort was invested in redesign

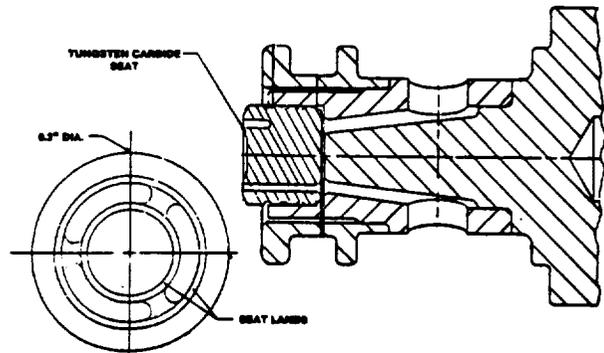
FIGURE 12.- APU SUBSYSTEM GGVM REDESIGNED SEAT AND MANIFOLD.

of the seat, in stress analysis, and in developing manufacturing processes. This effort resulted in an intricate seat design with concentric, dual-sealing surfaces and redesigned internal flow passages (fig. 12). The seat was diamond slurry honed as part of the manufacturing process to remove the recast layer left by the electrodischarge machining (EDM). This recast layer is a source of stress risers (cracks) and was considered one of the primary factors causing seat failure. The machining and manufacturing process turned out to be almost an art, and all seats and poppet assemblies were manufactured in a small, one-man shop.

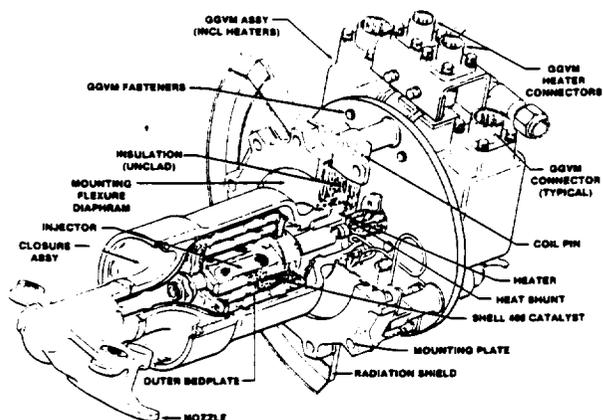
FIGURE 13.- MIN-MOD GAS GENERATOR - BASELINE.

A key component of the APU is the gas generator. The GG receives hydrazine from the GGVM in short controlled pulses. The fuel is injected (flows) radially into a Shell 405 catalyst bed, where it is decomposed into hydrogen, nitrogen, and ammonia. The resultant gas mixture leaves the bed at approximately 1200 psia and 1700° F. The performance and the useful life of the GG are measured by the stability of the decomposition process. Pressure fluctuations (roughness) of greater than ±10 percent of the steady-state level, pressure spikes (pulse spiking) of 2000 psia, or three consecutive pulses greater than 1900 psia indicate that the GG is no longer serviceable.

Key design features developed to extend useful GG life centered around the fuel injector and the catalyst bed. The size, the shape, the distribution, and the retention scheme for the catalyst granules were factors receiving significant development effort. The final design used had concentric, cylindrical beds separated by a cylindrical divider (figs. 13 and 14). The inner bed was packed with 14- to 18-mesh catalyst retained within a unique metal foam. The outer bed did not contain the metal foam. The technique used to pack the bed was found to be critical to good performance. This is an art-life operation consisting of pouring, shaking, tapping, and, in general, handworking the proper amount of catalyst into the bed. Because of the subjective nature of the operation, it has been, and still is, a basic concern in the manufacturing process.

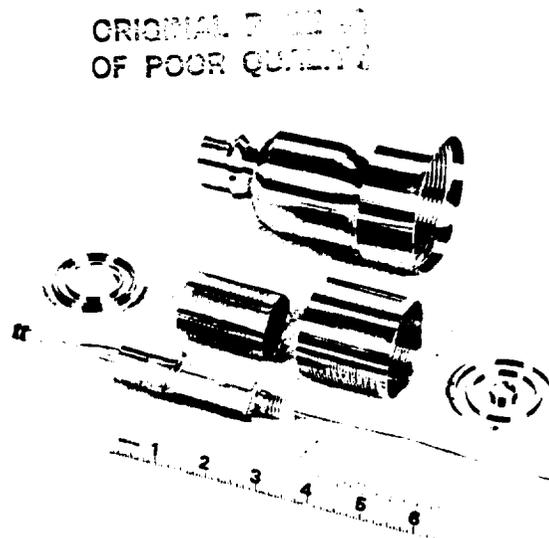
FIGURE 14.- APU GAS GENERATOR.

Injector design was also a critical element of GG performance. The current design consists of a core body with shaped fuel distribution channels feeding four injector panels. The injector panels are made from a sintered metal mesh material called Rigimesh (fig. 14). These panels produce uniform radial and axial distribution of fuel being fed radially into the catalyst bed. Design of the injector to produce uniform fuel distribution was a key element in extending GG life.

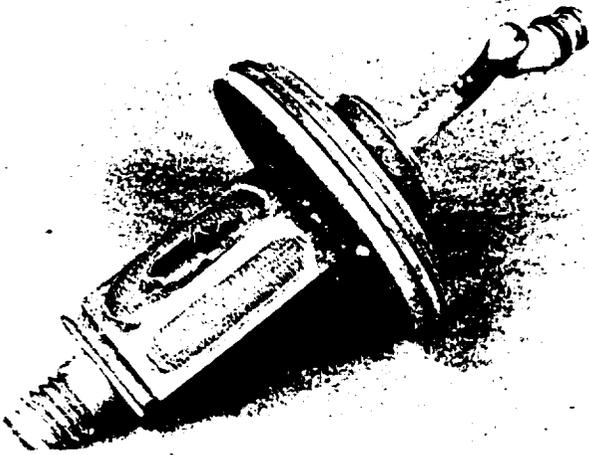
FIGURE 15.- APU GG INJECTOR FAILURE.

Thermal control within the GG was another area of significant concern. Overheating of the injector assembly during soakback after APU shutdown caused damage to the GG, damage to GGVM seals, decomposition of residual fuel in the injector upstream of the injector Rigimesh panels, and damage to the panels themselves (fig. 15). Early corrective actions included using a copper heat shunt between the injector and the GGVM mounting plate to dissipate some of the heat in the injector, and decreasing the thermal mass of the injector such that the incoming fuel could better cool the injector.

Even though these changes resolved the thermal concerns about the operating APU, it was found that if the APU restarted before the injector cooled to less than 400° to 450° F, the fuel would thermally decompose behind the injector panels and cause damage to the injector and would even feed back upstream to damage the GGVM. Limited hot-restart capability was finally achieved by adding an active water cooling system to the GG to be used only for hot restarts. This system injects water into a cavity within the injector. The steam thus generated is vented overboard (fig. 16). Use of this system enables restarts at any time after the cooling process, which requires a 210-second delay, is completed.

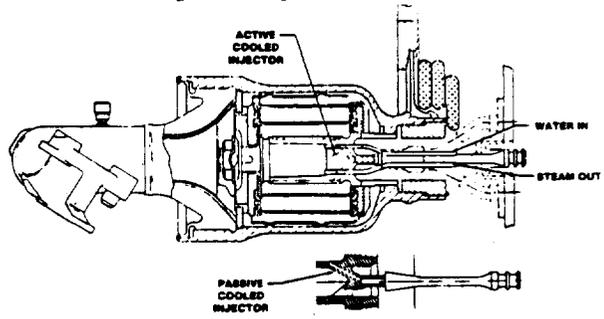
FIGURE 16.- GAS GENERATOR.

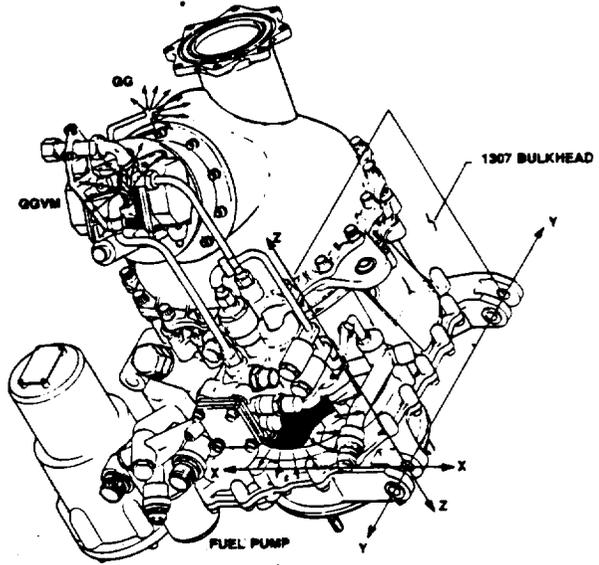
FIGURE 18.- ORBITER APU COOLING REGIONS.

The fuel pump and GGVM temperatures were controlled by use of an active water cooling system that sprays water externally onto the components (fig. 18).

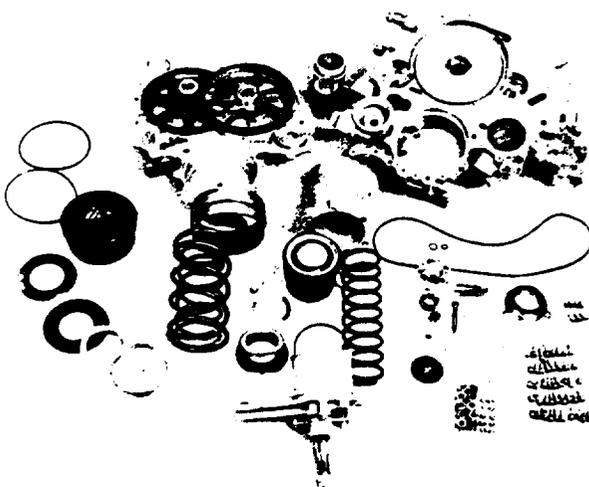
FIGURE 19.- GEARBOX.

The APU gearbox is required to reduce the 75 000-rpm turbine shaft speed to the hydraulic pump speed of 3700 rpm. It also drives the fuel pump and the lubrication oil pump. Development challenges were associated with the oil accumulators (required to control the oil-gas ratio in the gearbox), operation at low gearbox pressure, shaft sealing, and lubrication oil contamination. The oil accumulators in the gearbox control the quantity of oil in the lubrication circuit. To maintain proper lubrication oil flow and pressure, the ratio between oil and gas (void volume) must be controlled. Excessive oil causes churning and oil overheating, whereas insufficient oil causes inadequate oil flow. The original accumulators were pistons, sealed with an elastomeric diaphragm (Belloram, fig. 19). Failures of the diaphragm were common because of wear, scuffing, and folding as the pistons moved. The end results were contamination of the lubrication oil, leaks between the oil and gas side of the accumulators, and occasionally oil flow restrictions when a damaged diaphragm blocked the accumulator oil outlet passage. This problem was resolved by replacing the diaphragm with piston-ring-type seals made of Teflon.

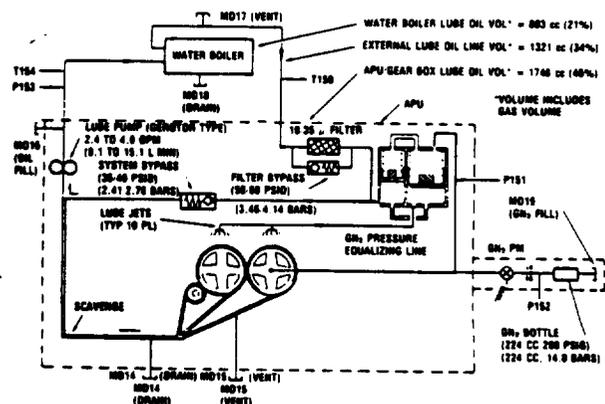
FIGURE 20.- APU LUBRICATION SYSTEM.

During the development test program, it was determined that if the pressure within the gearbox was less than approximately 1 psia, the oil pump was incapable of functioning in a satisfactory manner (i.e., low pressure could develop on orbit because of seal leakage). The problem was primarily due to low net positive suction head (NPSH) pressure at the pump, but because the system is a closed loop which is not completely filled, voids could also form at the pump inlet. It, therefore, became necessary to provide a fluid (gas or oil) for the pump to displace to assure presence of oil at the inlet. This problem was resolved by adding a gaseous nitrogen pressurization system which guarantees a minimum of 4 to 7 psia in the gearbox at startup and during operation (fig. 20).

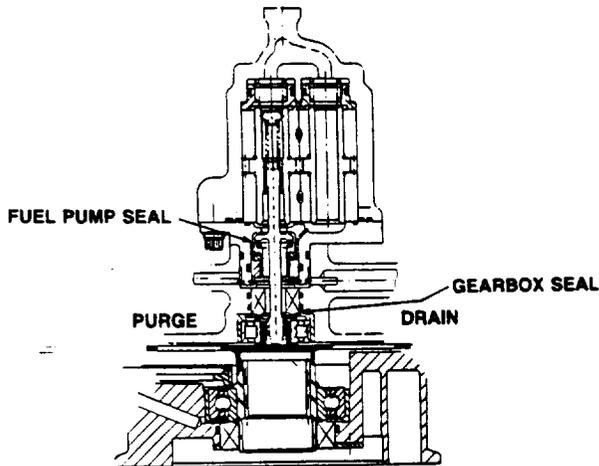
FIGURE 21.- APU FUEL PUMP.

The gearbox shaft seal at the fuel pump interface (bellows-type carbon-face seal) coupled with the shaft seal on the fuel pump posed problems that have not been solved (fig. 21). Slight leaks through these seals result in contamination of the lubrication oil with hydrazine. The reaction of the hydrazine with the lubrication oil produces contamination in the gearbox composed of a waxy, long-chain polymer (hydrazide) and a salt (pentaerythritol). The search for a hydrazine-tolerant oil is still in progress. Because free hydrazine in 270° F oil is dangerous because of the poten-

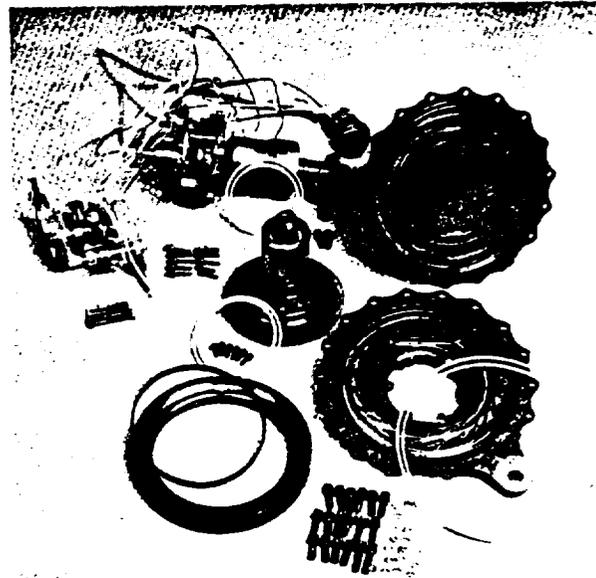
FIGURE 22.- GAS TURBINE MODULE.

Early in the development test program, it was discovered that the Stellite turbine containment housings and exhaust housings were cracking because of thermal cycling stresses (figs. 22 to 24).

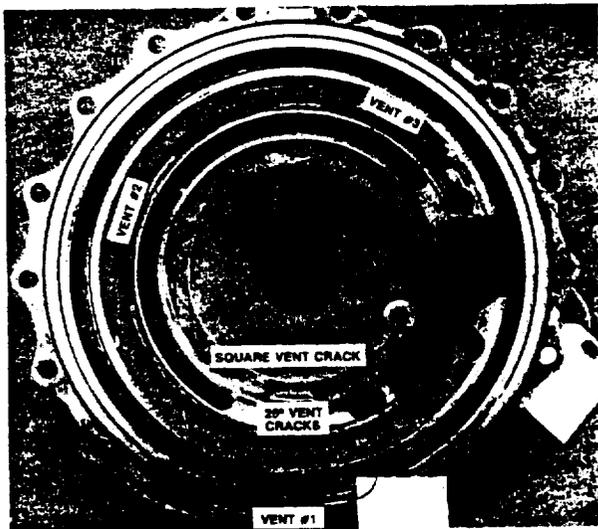
FIGURE 23.- TYPICAL EXHAUST HOUSING CRACKS.

Analysis results showed that the normal thermal cycles associated with starting and stopping the APU were causing stresses that exceeded the elastic limits of the Stellite. These cracks would develop within as little as 5 hours of APU operation. However, they were in noncritical areas and never adversely affected APU operation. The housings were qualified for 20 hours of operation with cracks. Part of the rationale used to support qualification with the cracks was that several cracked housings were used for more than 40 hours and two for more than 70 hours without any problems. The cracks were a concern, however; if the cracks were to continue to grow, housing failure would be theoretically possible. For this reason, a housing material change has always been high on the list of potential APU product improvement items. Sundstrand has fabricated housings using Udimet LX. Early development testing indicates that this material change could eliminate the cracking problem.

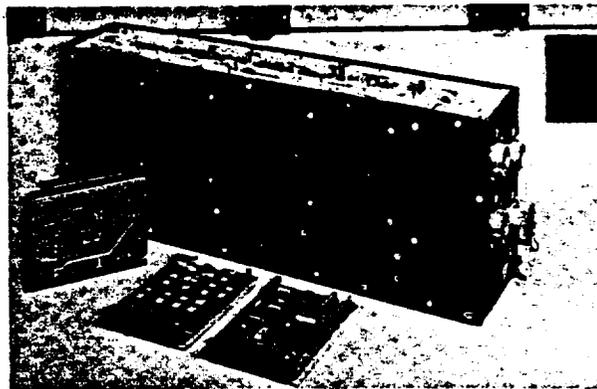
FIGURE 28.- ORBITER APU CONTROLLER.

The critical problem areas associated with the development of the APU electronic controller (fig. 28) were basically not in design. There were some design iterations associated with reducing the complexity of the unit, primarily in the built-in test equipment (BITE) circuits, and some changes were made to provide redundancy for the higher stressed components. However, the significant challenges were associated with manufacturing. Basic deficiencies in manufacturing procedures, equipment, specifications, and technician skill caused problems in being able to repeatedly build high-quality hardware. Development of proper wave soldering techniques and procedures was also required. Once adequate specifications, manufacturing procedures, and quality control procedures were written, and the technicians were properly trained, the controller became a very reliable and trouble-free component.
